Five-Year Review Report

Second Five-Year Review Report for Fort Richardson, Alaska

February 2008

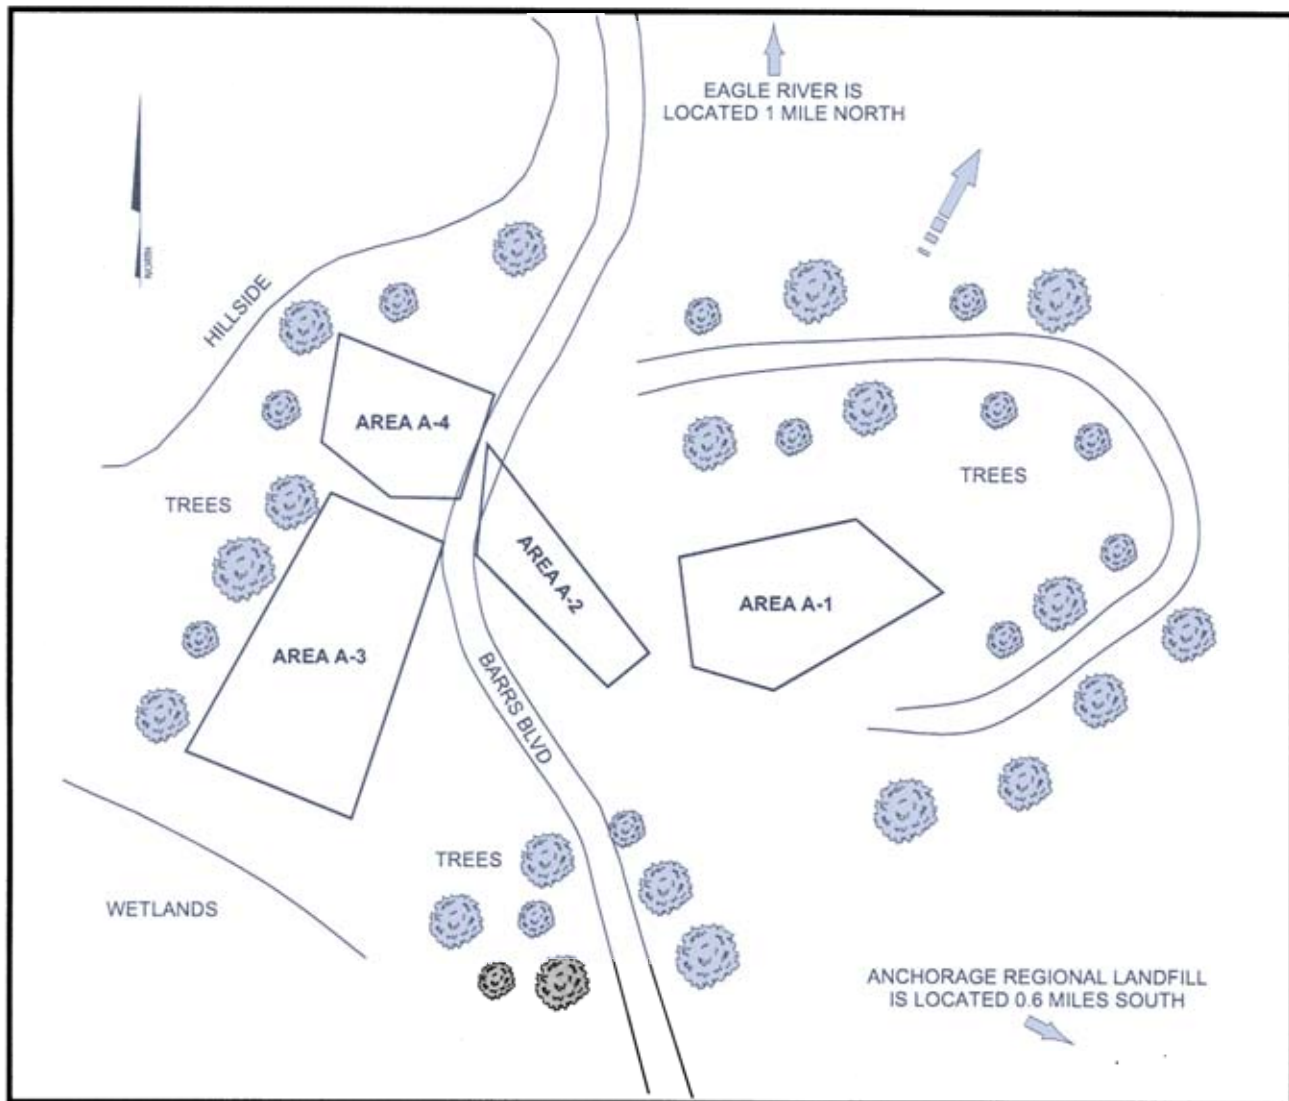
ARMY ENVIRONMENTAL CENTER		CORPS OF ENGINEERS ALASKA DISTRICT
Poleline Road Disposal Areas			
Second 5 Year Review Operable Unit B Fort Richardson, Alaska			
SOURCE:	NA	FIGURE:	5 - 1
DATE:	2/08

Two former soldiers stationed at Fort Richardson in the 1950s identified the Poleline Road Disposal Area in 1990. It was determined that four chemical disposal areas were used from 1950 to 1972. During this time, chemical agent identification sets and other military debris were burned and disposed in trenches. The chemical agents were neutralized with a mixture of bleach or lime and chlorinated solvents before burial. Based on maps, aerial photography, and geophysical surveys, Poleline Road was divided into four disposal areas; Areas A-1, A-2, A-3, and A-4. Figure 5-1 is a site map of Poleline Road showing the locations of the disposal areas.

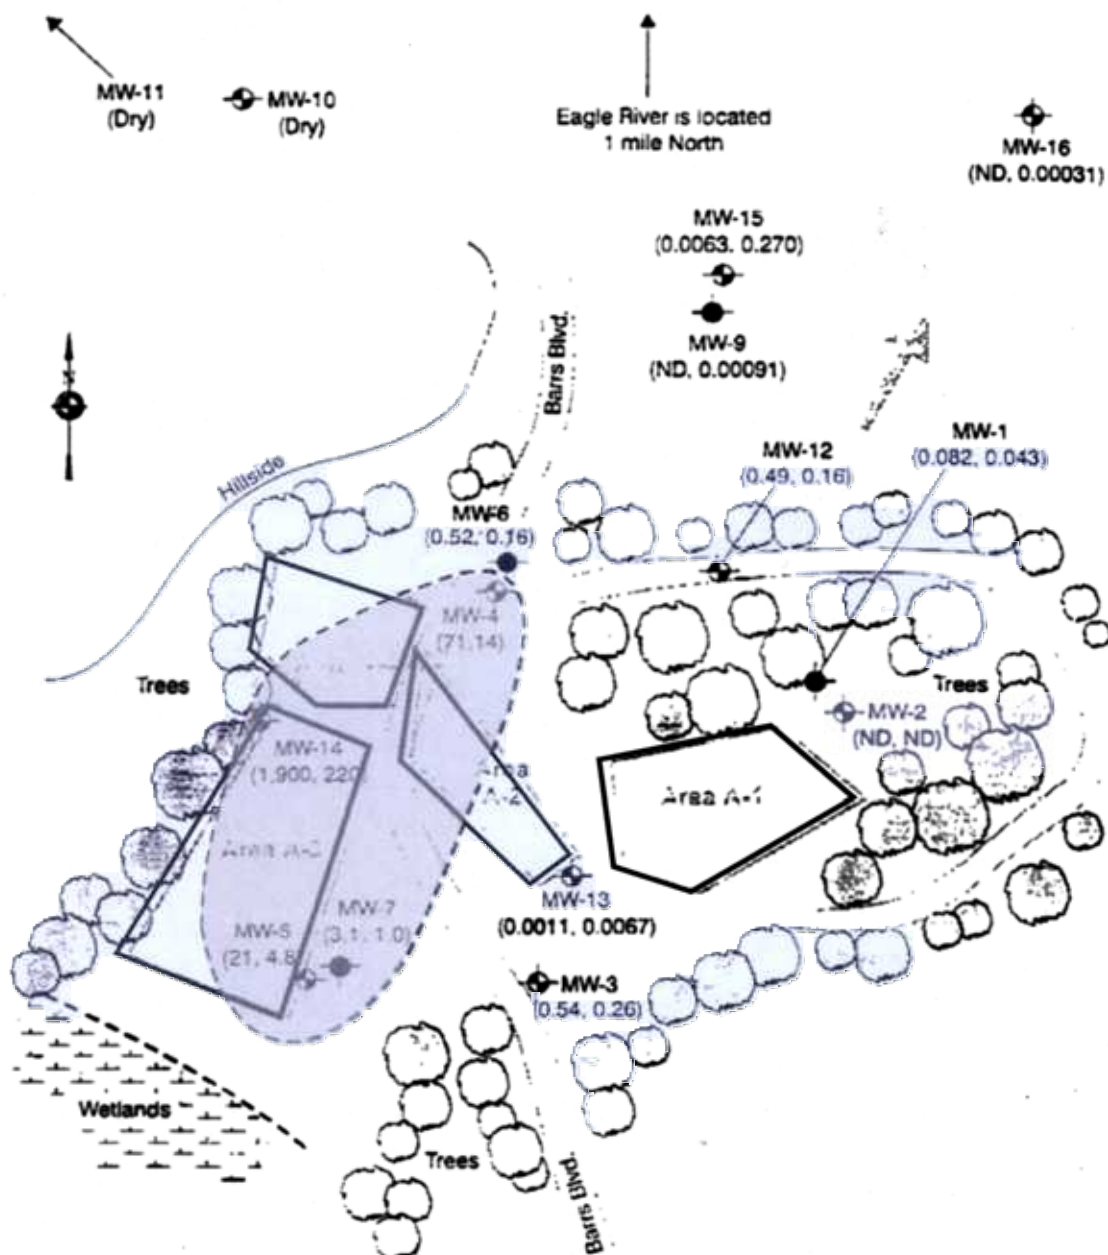
ARMY ENVIRONMENTAL CENTER		CORPS OF ENGINEERS ALASKA DISTRICT
Hot Spot Area Identified at Poleline from the ROD Second 5 Year Review Operable Unit B Fort Richardson, Alaska			
SOURCE: NA		FIGURE: 5-2	DATE: 2/08

- Monitoring well completed in perched interval
- Monitoring well completed in shallow interval
- Monitoring well completed in deep aquifer
- (x,y) 1,1,2,2-Tetrachloroethane, TCE (units - mg/L)
- Estimated boundary of hotspot
- Approximate groundwater flow direction in shallow interval and deep aquifer

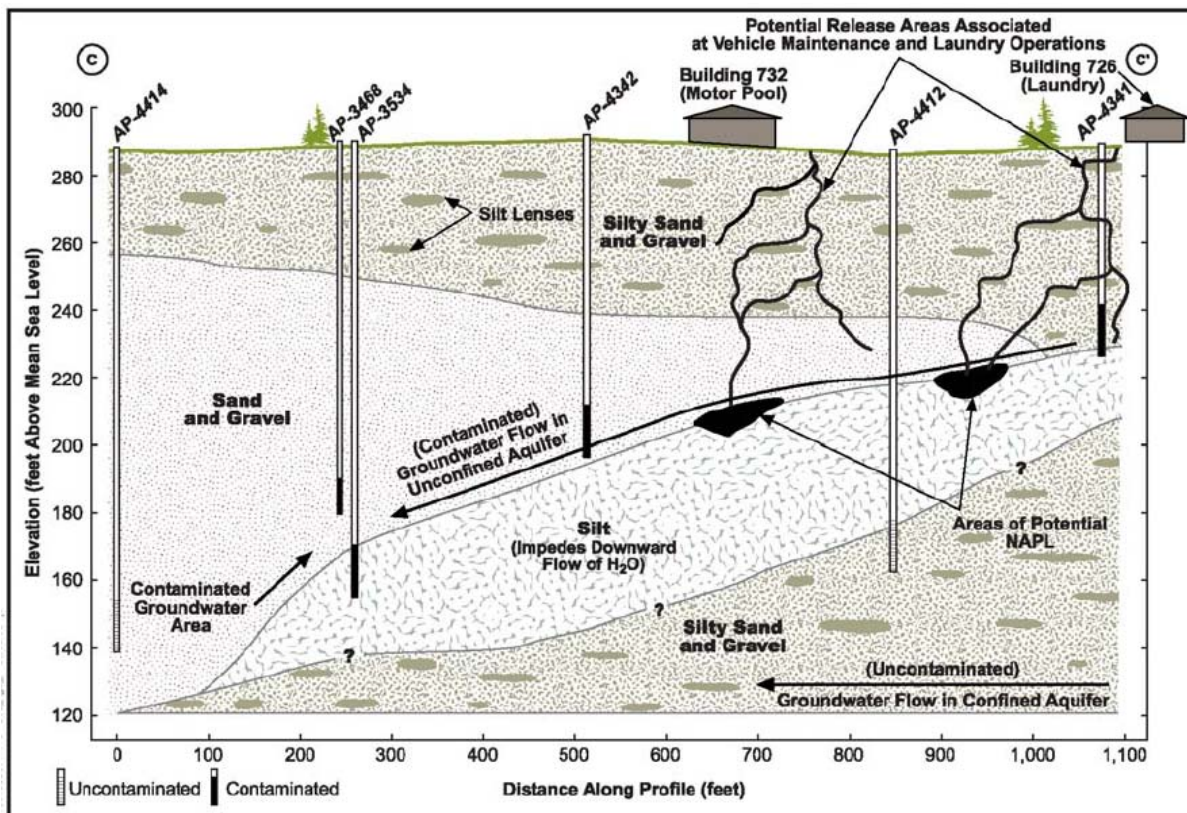
Figure 8-2. Conceptual Cross-Sectional Model of the AVMA Site

The AVMA area covers approximately 140 acres of developed and undeveloped land. The undeveloped land consists of forested areas and some open fields. The site also has several buildings with associated parking lots, including: a laundry facility (Building 726), a commercial building (Headquarters for the Directorate of Public Works), a military motor pool (Building 732), and a military training facility (Building 733). The downgradient area north of Building 732 has been used as a training area and obstacle course since 1973. The Army is in the process of reconstructing a jump tower at the site, and will be upgrading the training facilities (obstacle course) at the site during the next several years.

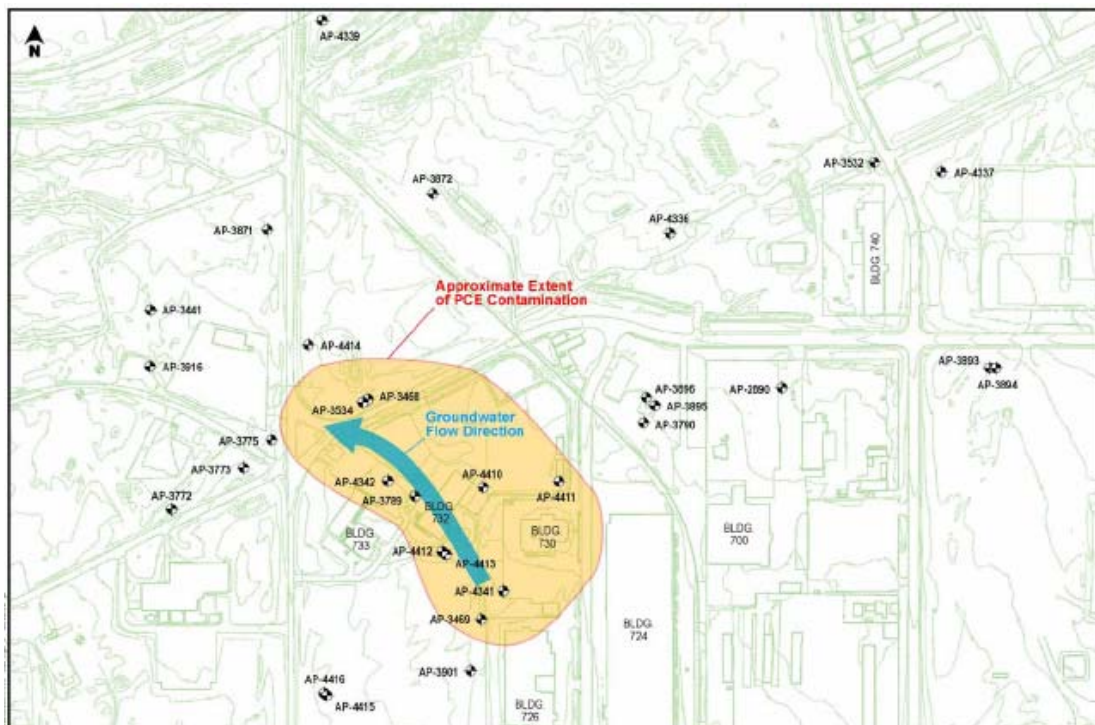
Figure 8-3. Extent of PCE Contamination in the Groundwater at time of ROD

- Where contamination was encountered it extended from an area immediately downgradient from Building 726 to slightly past the junction of the confined and unconfined aquifers north of the Davis Highway. PCE contamination was detected in the shallow unconfined aquifer underlying the Building 726 and 732 areas, but not in the deeper confined aquifer located under those sites.
- PCE contamination exceeding the MCL was detected in the area where the unconfined and confined aquifers merge (wells AP-3534 and AP-3468). Groundwater found at, and downgradient from, wells AP-3534 and AP-3468 contains high metals levels and PCE.

Ongoing monitoring indicates that the contaminant is slowly attenuating downgradient from the point of origin near Building 726. The primary means of attenuation appears to be dilution. Since no significant concentrations of breakdown products have not been found, chemical degradation does not appear to be a major pathway of contaminant reduction at this site.
